PUKAKI AERODROME (2)

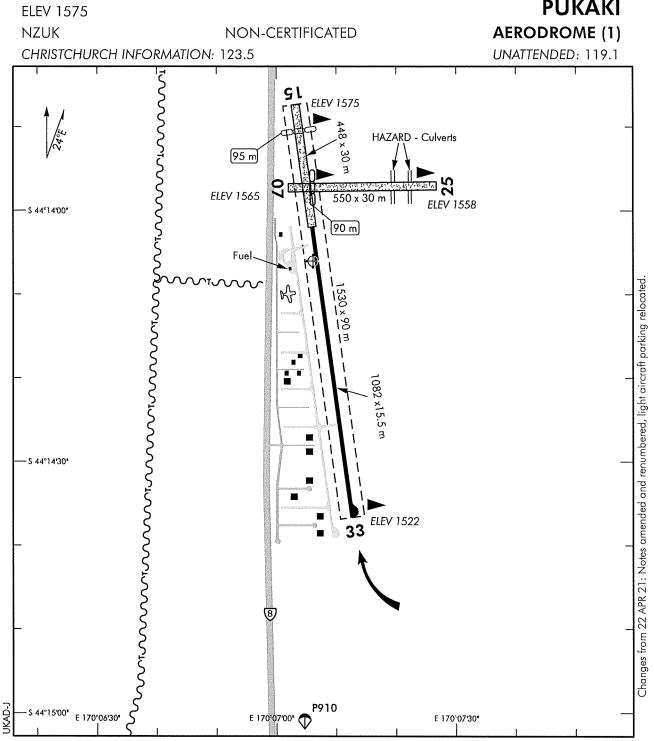
- ${f D}$ 1. Take-off RWY 33 Turn right 20° crossing northern aerodrome boundary.
 - 2. Grass surface may soften during thaw.
 - 3. **CAUTION:** Occasional parachuting operations.
 - 4. Extensive daily parachute operations take place over Pukaki AD year round from surface to 17000 ft. Pilots should avoid using the overhead join procedure while parachuting is in operation. PLA located 900 m south and 200 m west of centreline of RWY 33. Parachute activity will be broadcast on 119.1 MHz. If unsure, communicate directly with parachute aircraft for safety.
 - 5. Due to parachute operations, no NORDO is permitted without prior approval of Airport Operator.
 - 6. There is NO parallel grass runway adjacent to the sealed portion of RWY 15/33.

- 7. Areas of uneven ground exist between the seal and adjacent grass areas.
- 8. **CAUTION:** Rabbit holes can occur on unsealed areas. Pilots should exercise caution when manoeuvring on these areas.
- 9. Aircraft parking located adjacent to the fuel installation.
- 10. CAUTION: Twizel Medical Centre HLP (NZTW) lies to S (198°/1.4 NM).
- 11. More information about Pukaki Airport is available at www.airportpukaki.co.nz.
